Refurbishment Solutions for Various Field Pole Problems

Bill Moore, P.E.

National Electric Coil

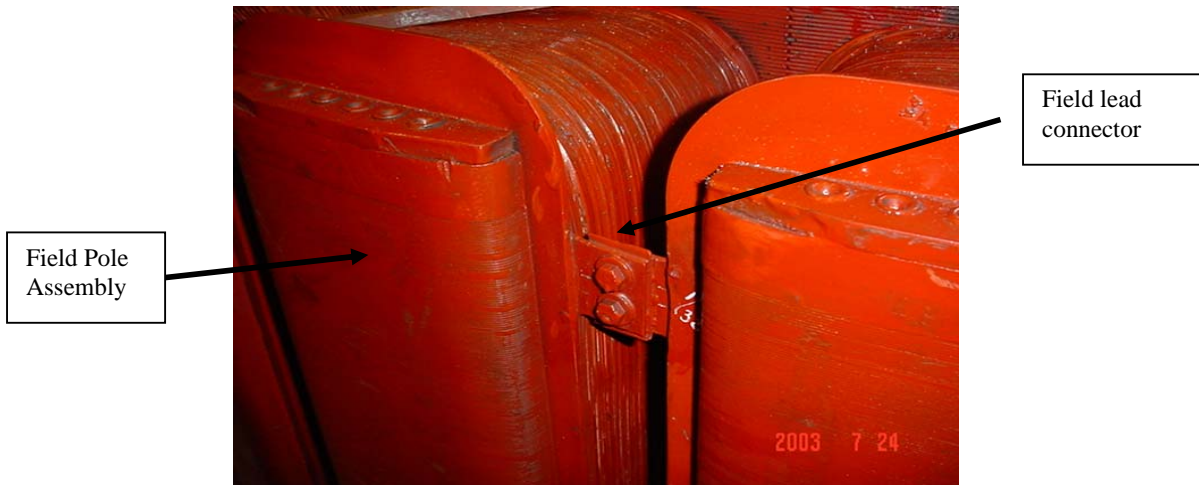
Fig. 1. Configuration of Field Winding Lead Connector

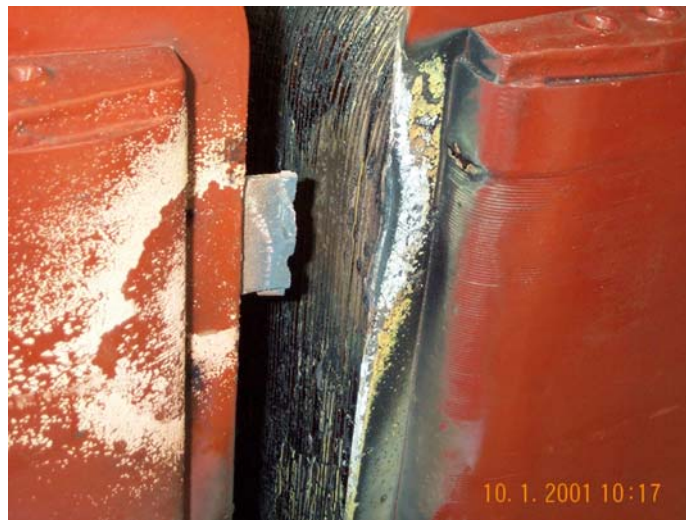
Fig. 2. Failed Lead Connector

Investigations into the failure revealed looseness of the pole pieces where they are secured to the rotor spider. Tangential vibration of the pole pieces during operation placed stress on the solid copper leads and resulted in fatigue crack initiation. The vibration was believed to be the cause of this problem and a multifaceted approach was taken to address the root cause.

Closer inspection of the geometry of the dovetail design for mounting of the poles revealed that a radius in the rotor spider dovetail section was too small to allow the pole piece to be pulled up tight to the spider mounting surface. Also, the rotor spider pole mounting surface was inspected and found to be concave over the entire circumference as a result of distortion during many years of operation. Additionally, it was thought that unevenness of the laminations where the keys are located would limit how tightly the keys could be driven.

LCRA and NEC agreed to make modifications to the rotor design to address these issues and the following three changes were incorporated.¹ First, the rotor spider dovetail slot section was carefully ground down to increase the radius of the edge. This would prevent the pole piece dovetail from bottoming out when the keys are driven, allowing better seating of the pole. Second, the pole body was modified by milling out a 0.010 inch deep area on both sides of the pole piece back iron next to the dovetail area. The machined area extended to within 1 inch of

the outer edge of the back iron surface. This machined area would allow better seating of the pole against the rotor rim, and increase pole stability by providing a land area on the outer edge of the pole. Lastly, a three-piece key design, consisting of a flat shim against the uneven dovetail groove, and two tapered keys. The tapered drive key was now allowed to drive against a smooth, machined surface, rather than the uneven laminations. This helped remove any possibility of the leading edge of the key snagging on a lamination edge and giving a false sense that the key has been securely driven in place.

As an added measure, to accommodate any possible movement of the pole pieces during operation, flexible copper leads replaced the original solid copper design and would allow for some flexing of the poles without inducing sufficient stress on the leads to cause cracking and eventual failure. A drawing of the added flexible leads is shown in Figure 3 below:

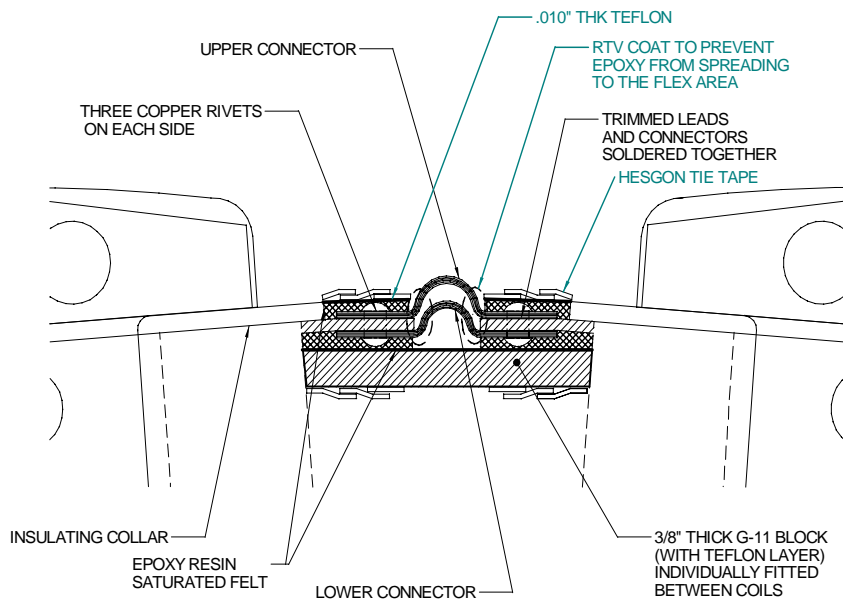
Fig. 3. New Field Coil Lead Connector Design

Both rotors of Buchanan Unit #1 and Unit #2 have been modified to incorporate these changes and been in service for over one year. No failures have occurred to date since these changes have been made and it is believed that these modifications will provide many years of service.

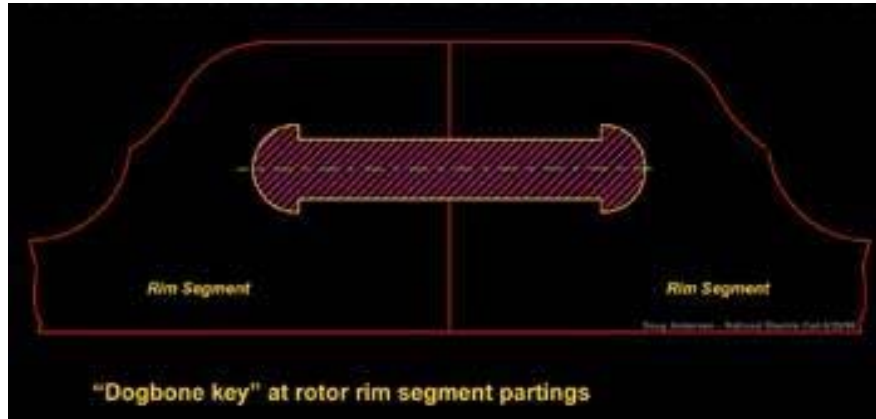
Fig. 4. Depiction of “dogbone” key between rotor rim segments.

Soon after the machine was reassembled with the new stator winding and new field poles, a field lead connector failed. Upon inspection and root cause analysis, it was discovered that the rim segments were slightly offset at the parting line between segments. The segments had become warped and distorted over years of operation, and did not perfectly mate back up during final re-assembly.

Allowing the unit to return to service, and experience several mechanical and thermal stress cycles, enabled the parting segments to properly realign. The original offset disappeared. The field poles that were once tightly bolted over the offset at the parting line, were now loose, as the parting segments aligned back into place. The mating back to their original position created “slop” in the assembly. Accordingly, the pre-tensioned field pole bolts on the pole piece bridging the rim split, suddenly lost much of their tension. This event had the effect of allowing the field pole bolts to loosen, and hence allow the field pole to loosen on the rotor. The loose field pole then vibrated until a failure of one of the field lead connectors occurred.

The resulting looseness on the pole created an audible hum during operation and resulting fatigue on the pole to pole connectors. Once the problem was identified, the pole bolts at the rim split were retorqued, and the associated field lead connectors renewed. These pole to rim assemblies have given many years of service and reliable service since this point in time.

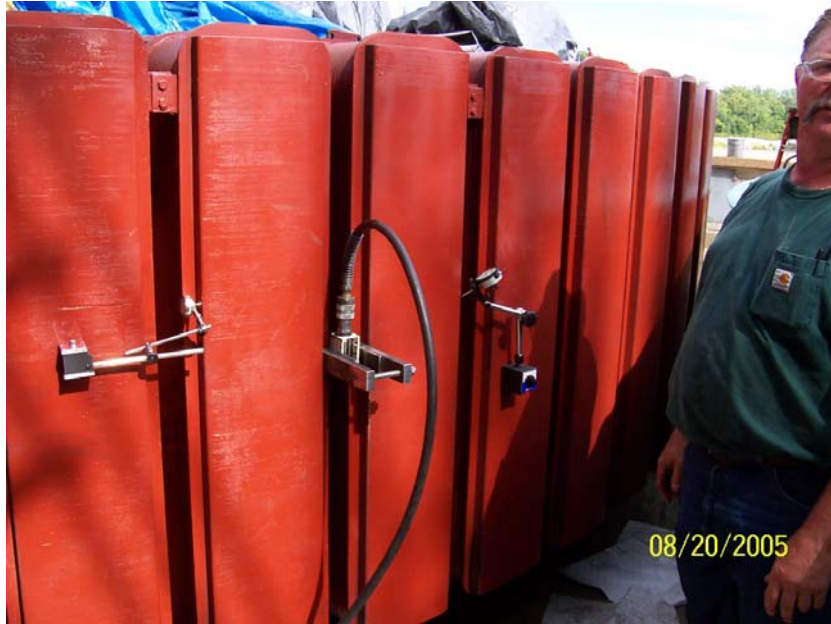
Fig. 5. Pole jacking assembly with dial indicators used to measure pole movement.

A pole jacking test (see Fig. 5 below) done after pole assembly can verify that the poles are tight. A hydraulic button jack can be placed between two poles, and with an appropriate fixture, pressure can be exerted on the poles to verify tightness. Dial indicators are used to verify pole movement. Movement of a pole more than 0.001 inch warrants extra attempts to drive keys even tighter.
