## SES 200: Rotor Turn Insulation Migration

Specialized Engineering Solution™ 200-TE-1008

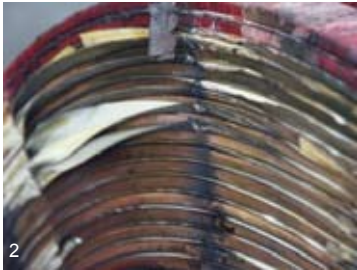
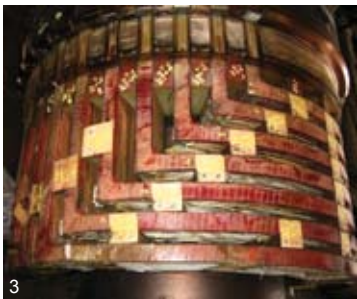
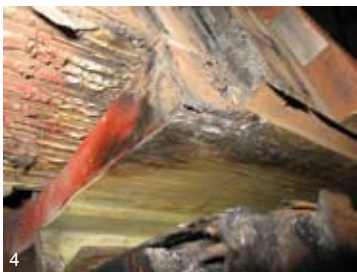
(1-2-3) Turn insulation migration found during incoming inspection is quite evident in the end turn areas. (4) Extent of damage found in slot when turns were removed. This rotor was rewound using NEC's long-term solution to the problem. (5) Rewound rotor prior to shipment.

- Rotor turn insulation adhesive breakdown

- Shorted turns
- Reduction in excitation capacity
- High vibration

The insulation slippage is caused by an adhesive breakdown, causing the resin bond between the insulation and the copper to separate. Because of the wide extent of the problem, NEC developed its Specialized Engineering Solution™ (SES) for generator field endwinding insulation migration. The success of the NEC's solution has been demonstrated in more than ten rotor rewinds in the last few years.

NEC's SES™ not only incorporates a superior adhesive to hold the insulation in place, it also employs a unique, specially-designed positive locking system. The system's design prevents the insulation from migrating out of the end turns.
