# NATIONAL ELECTRIC COIL®

## SES 503: Spark Erosion May Lead to Premature Winding Failure in Large Air-Cooled Generators

Specialized Engineering Solution™ 503-ΩH-1008

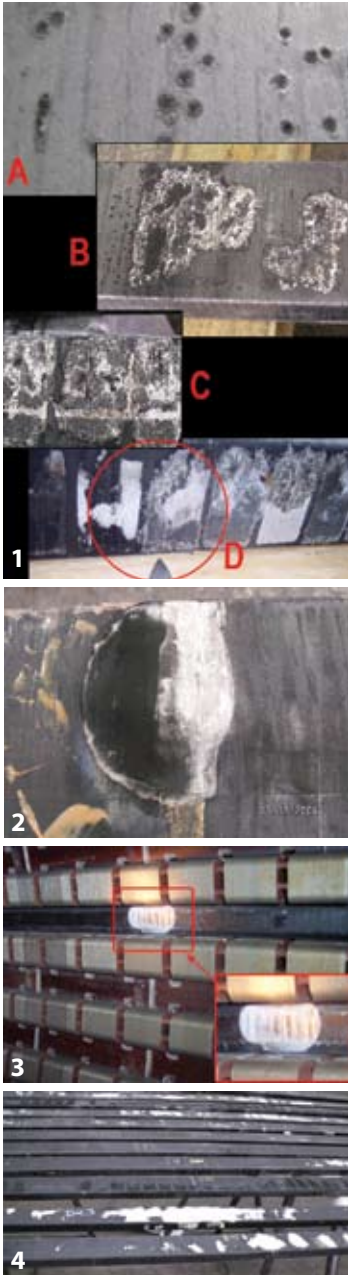
(1) Examples A-D show the progression of groundwall deterioration initiated by spark erosion. In example D, the tip of a knife blade at the bottom of the circle points to the failure site. (2) In some units, premature bleaching of the slot cell semi-conductive tapes has been found. (3) Bleaching in the slot. (4) A number of bars from one unit were examined and tested in our factory in order to document failure sites and mechanisms. Design for the new winding has successfully addressed these issues.

NEC's replacement winding includes design improvements that resolve OEM issues with spark erosion. Our improved design may include some or all of these options:

- Installation of robust semi-conductive side ripple springs that will maintain coil to core iron contact, negating the damaging spark erosion.
- Improvement of dielectric strength of the groundwall, reducing stresses on the coil insulation.
- Thorough inspection of the stator core slots for irregular surfaces that could create unwanted gaps between the coil and the iron.
- Special manufacturing process to ensure a super-smooth bar surface faces in the slot
- Use of an advanced semi-conductive compound in the slot to eliminate gaps that can lead to spark erosion
- Improvement in design clearances to lower the probability of partial discharge activity and damage in the end turns
