TMM 601: Hydrogenerator Rotor Rim Shrink Age Causes Deviation from Original Circular Shape

NEC's Technical Maintenance Memo™ Recommendations

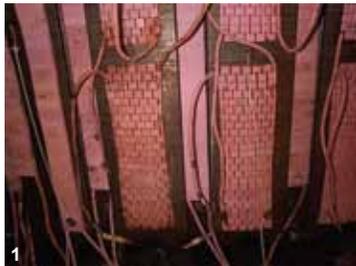
(1) Heaters applied to outer diameter (OD) of rotor rim. (2) Rim wrapped with blanket insulation. (3) Heating is carefully monitored and controlled. (4) Installing new keys in place. (At top right) Cross section of rotor shaft, hub, spider arm, rim and pole area, shown at running speed.

Heating of the rim requires careful planning and execution. Temperature spikes could warp the rim, affecting the rotor balance or changing the metallurgical properties of the material. Typically, the rim is heated uniformly by ceramic type resistive heaters applied to the rotor rim. Custom-made heating blankets are wrapped around the rim to retain and distribute the heat uniformly. Temperature recording charts are used to monitor the temperature of the rim at all times at uniform spaces around the circumference. All heating is controlled and monitored.

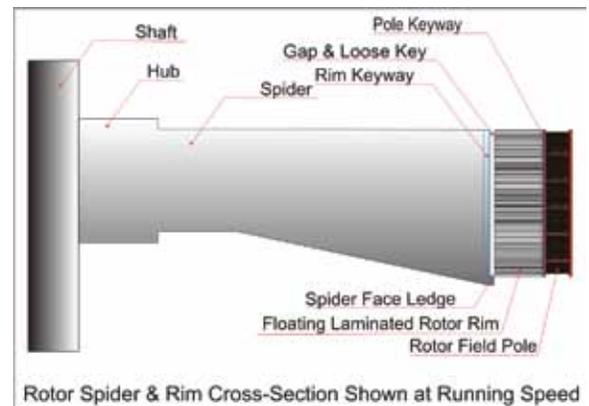
Rotor Spider & Rim Cross-Section Shown at Running Speed

As hydrogenerators age, their laminated rotor rims relax, deviating from their original circular shapes. The tight shrink fit loosens between the end of the cast or fabricated rotor spider arms and the rim. The rim takes on more of a polygonal configuration, and the keys that align the rotor spider end arm to the rotor rim become loose at operating speed. With repeated start-stops and thermal cycling, this condition worsens. It can lead to an irregular air-gap, accentuated magnetic forces between the rotor poles and the stator winding, fatigue, loss of rotor center, balance issues and further deterioration.

The radial shrink between the spider and the rim also can loosen due to the centrifugal forces from the mass of the rim. This causes further loss of shrink fit between the rim and the spider keys causing the rim to float.
