Field Pole Attachment Cracking on Hydrogenerators

Bill Moore, P.E.
Director, Technical Services
National Electric Coil
bmoore@national-electric-coil.com

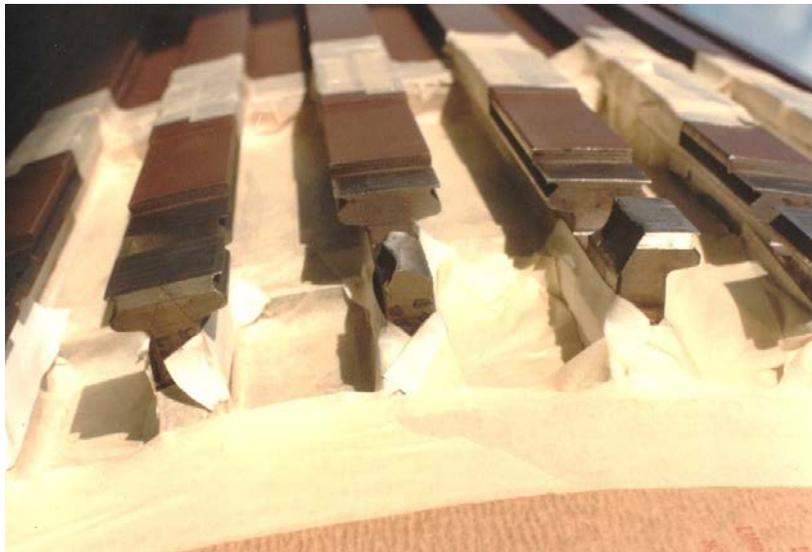
The very first identified case of tooth top cracking occurred at the Manatee Plant. It was unusual because no operational issues were reported prior to shut down. When the retaining rings were removed, broken tooth top sections fell out of the rotor. Figure 3 below shows a few of the broken tooth tops, some with cracks all the way through the tooth top and the section fallen away, and another with the section still in place.

Figure 3 showing Manatee rotor with cracked and separated rotor tooth tops.

This unit was a large 800 MW unit that was known to cycle frequently – almost daily. This frequent cycling not only initiated the cracks, but led to their full propagation and failure when they reached their critical length. What is quite unusual in this instance is that no operational issues were noted prior to shut down and disassembly. In fact, this failure mode occurring on many, many, rotors, has never been known to cause a forced outage during operation. The reason is that the tooth tops are constrained and contained by the shrunk on retaining ring.

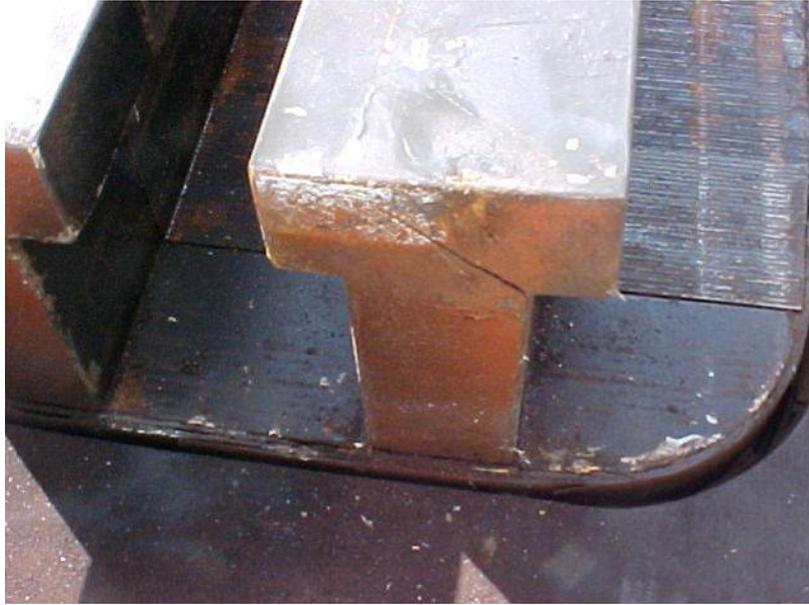
- T-heads on field pole endplates were observed to have radii as sharp as a right angle up to 1/32 inch – no larger than 0.030 inches.
- Lamination radius was measured at 1/16 inch.
- 16 rotor field pole endplates were cracked.
- 14 poles out of 30 poles had one endplate that was cracked.
- 1 pole out of 30 poles had both endplates cracked.
- 4 poles had cracks extending into pole body laminations – in one instance up to 3 inches.
- All cracks were located at the Tee head corner away from pole centerline.

Figure 5 above shows attachment crack almost completely through the Tee head section.

The cracks on these field pole attachments were fully evaluated metallurgically. They were determined to be fatigue, with very little tearing and shearing at the end of the crack. This implies that the mean stresses are low.

For this refurbishment project, all cracked field pole endplates were replaced. For those that were not replaced, the radius was enlarged to 0.064 inches in all cases. All field pole laminations that were cracked were replaced.

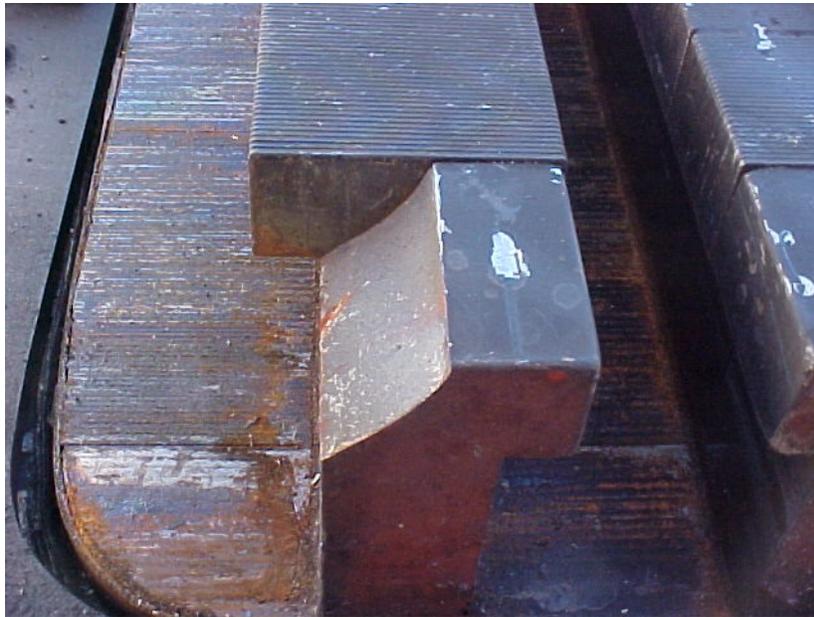
Figure 6 above shows crack completely through Tee head section. Note the similarity in the failed tooth top shown previously in Figure 3.

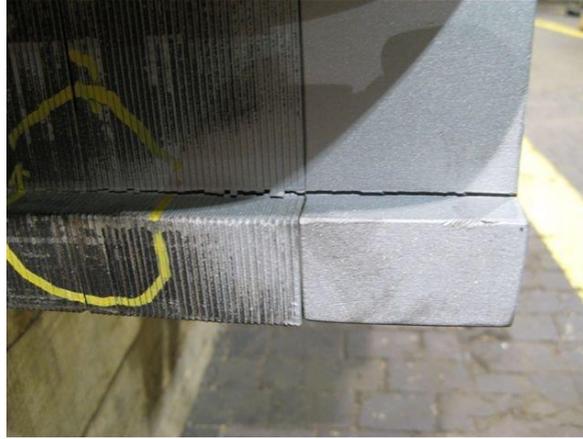
Figure 7 above shows crack progression through end plate well into pole laminations.

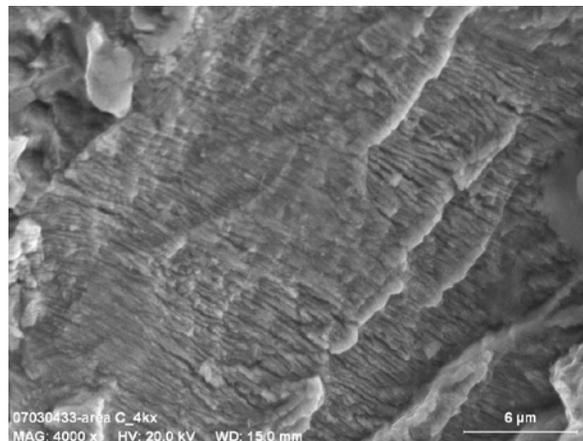
SEM (Scanning Electron Microscope) photos showed fatigue striations across the entire length of the fracture surface. The fatigue striation density indicated that on the three cracks examined, the number of starts would be estimated to be in the 100,000 to 140,000 cycle range. This is considerably more than the estimated actual number of starts of 40,000 reported to be on the unit. This finding may indicate that an additional stress component may be in play during the cycling mode. Figure 8 below shows the fracture surface magnified at 4000 times.

Figure 8 above shows SEM photo of fracture surface at 4000X.

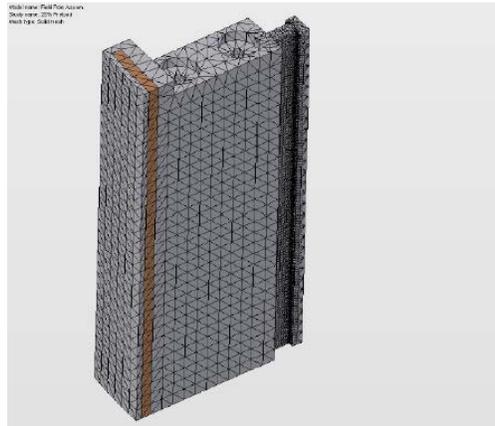
Figure 9 above shows FEA model of the field pole.

Stress concentration factors in the original geometry were estimated at 9.38, with a maximum stress level at 46,000 psi. As with the case of Tooth Top cracking on turbogenerators, the fillet radii size is crucial in determining whether cracks initiate or not. A very small fillet radius, or none at all, cause crack initiation much, much sooner, as would be expected. Large, generous radii in the high stress fillet area can significantly extend life and future start/stop cyclic capability. Multiple radii were analyzed for this specific geometry and loading conditions with one FEA plot of the enlarged fillet radii as shown below.

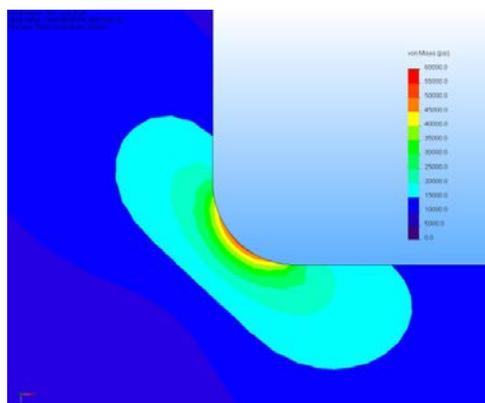
Figure 10 above shows FEA of the fillet radius of the field pole attachment.
