# NATIONAL ELECTRIC COIL®

Specialized Engineering Solution™ SES-407-AM-0807

## SES 407: Repairs to Corona Suppression Systems

**A Stator Winding May Show Visual Signs of Corona Activity or High PD Readings**

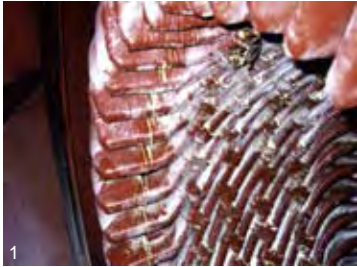
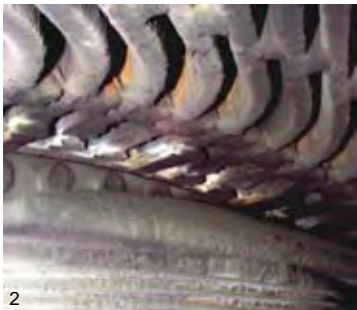
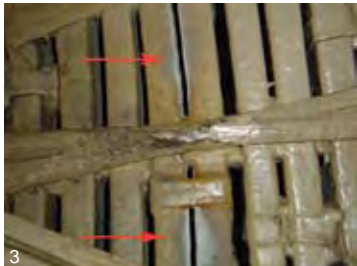
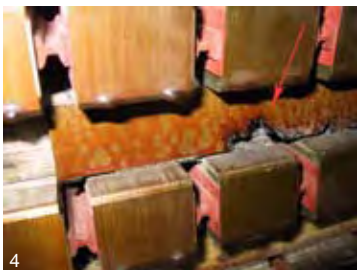
(1) Evidence of excessive corona activity on the end winding of an air-cooled generator. (2) Corona activity often occurs near the end of the core. (3) PD often occurs between adjacent bars, especially if they are too close or are in different phase groups. (4) Damage can also occur in the slots. Severe damage can deteriorate slot fillers. (5) NEC is an expert in corona suppression applications. Our R&D department continues to develop the best corona suppression materials in the industry for use in our manufacturing.

Industry-wide, corona damage to stator windings is receiving more attention. This condition is usually observable in air-cooled generators where it is seen as a white substance, in and around the end of the stator core, often between adjacent coils in the end arm area. Excessive corona activity can ultimately lead to a stator winding ground fault requiring partial or full winding replacement. Repairs may be possible, depending upon the machine's original design.

NEC has a five-step approach for determining if a unit is a good candidate for a Corona Suppression System repair.

First, the stator winding must be carefully inspected in order to identify the sites of all existing areas of corona damage.

Second, the inspection will also document sites vulnerable to future corona activity.

Third, a determination must be made as to the compatibility and viability of repairs to the existing stator winding insulation and corona protection systems.

Fourth, it must be shown that it is possible to set up a monitoring program to monitor and evaluate future corona activity.

Last, steps must be developed that will minimize the effects of a long, forced outage should the inevitable failure occur. This could include data banking (see TMM 402), the design and manufacture of a "Coil Ready Package" (see SES 401) or a spare winding (see SES 403).
