Field Pole Attachment Cracking on Hydrogenerators

Bill Moore, P.E.
Director, Technical Services
National Electric Coil
bmoore@national-electric-coil.com

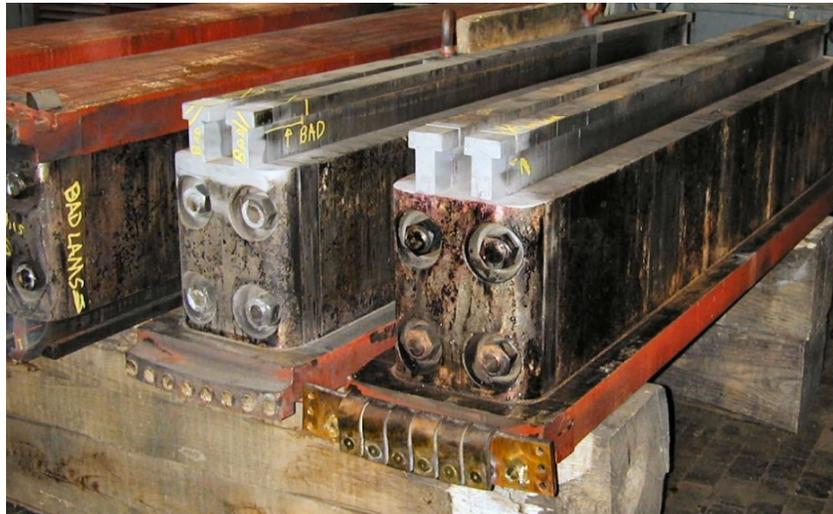
This unit has a double Tee head field pole attachment arrangement. There is a steel endplate on each end of field pole body. Four, 1.5 inch diameter bolts are used to clamp the pole assembly together. The pole is secured to the rotor with twin "T" shaped dovetails running the length of the poles. Amortisseur bars pass through clearance holes in the pole end plates. Figure 4 is a photo of the these field poles.

Figure 4 above shows the Yards Creek unit field pole attachment arrangement.

The field poles for this unit were refurbished in 2007. During the inspection that typically occurs during the refurbishment process, cracks were identified in the Tee head fillet radius. A summary of the inspection findings are as follows:

- T-heads on field pole endplates were observed to have radii as sharp as a right angle up to 1/32 inch – no larger than 0.030 inches.
- Lamination radius was measured at 1/16 inch.
- 16 rotor field pole endplates were cracked.
- 14 poles out of 30 poles had one endplate that was cracked.
- 1 pole out of 30 poles had both endplates cracked.
- 4 poles had cracks extending into pole body laminations – in one instance up to 3 inches.
- All cracks were located at the Tee head corner away from pole centerline.

For this refurbishment project, all cracked field pole endplates were replaced. For those that were not replaced, the radius was enlarged to 0.064 inches in all cases. All field pole laminations that were cracked were replaced.
